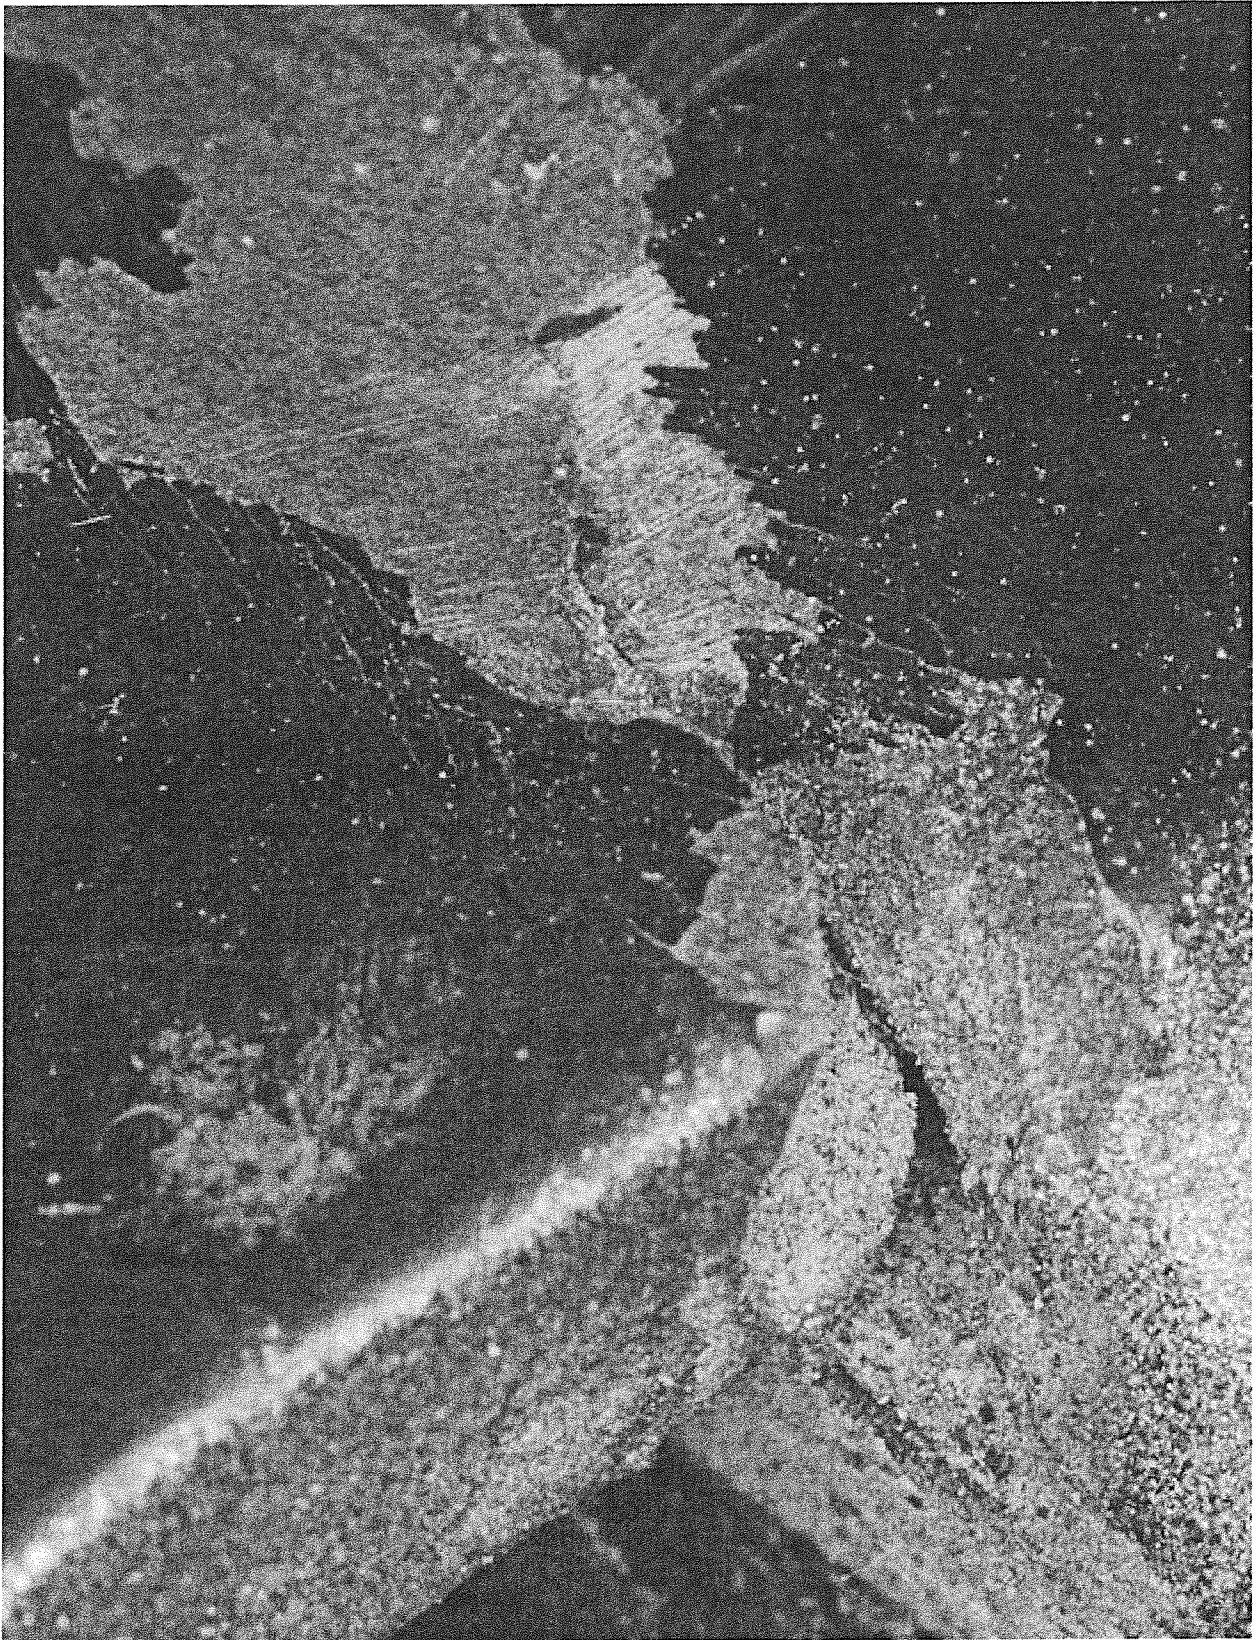
Figure 3. Picture showing the extent of the fracture into the width and thickness of the link.
